RESERVE STUDY

The Groves at the Villages of Wetherington Condominium Association

Wooster, Ohio

**Study Completed By:
Superior Engineering - Ohio**
6673 Eastland Road
Middleburg Hts., Ohio 44130
(440) 234-9972

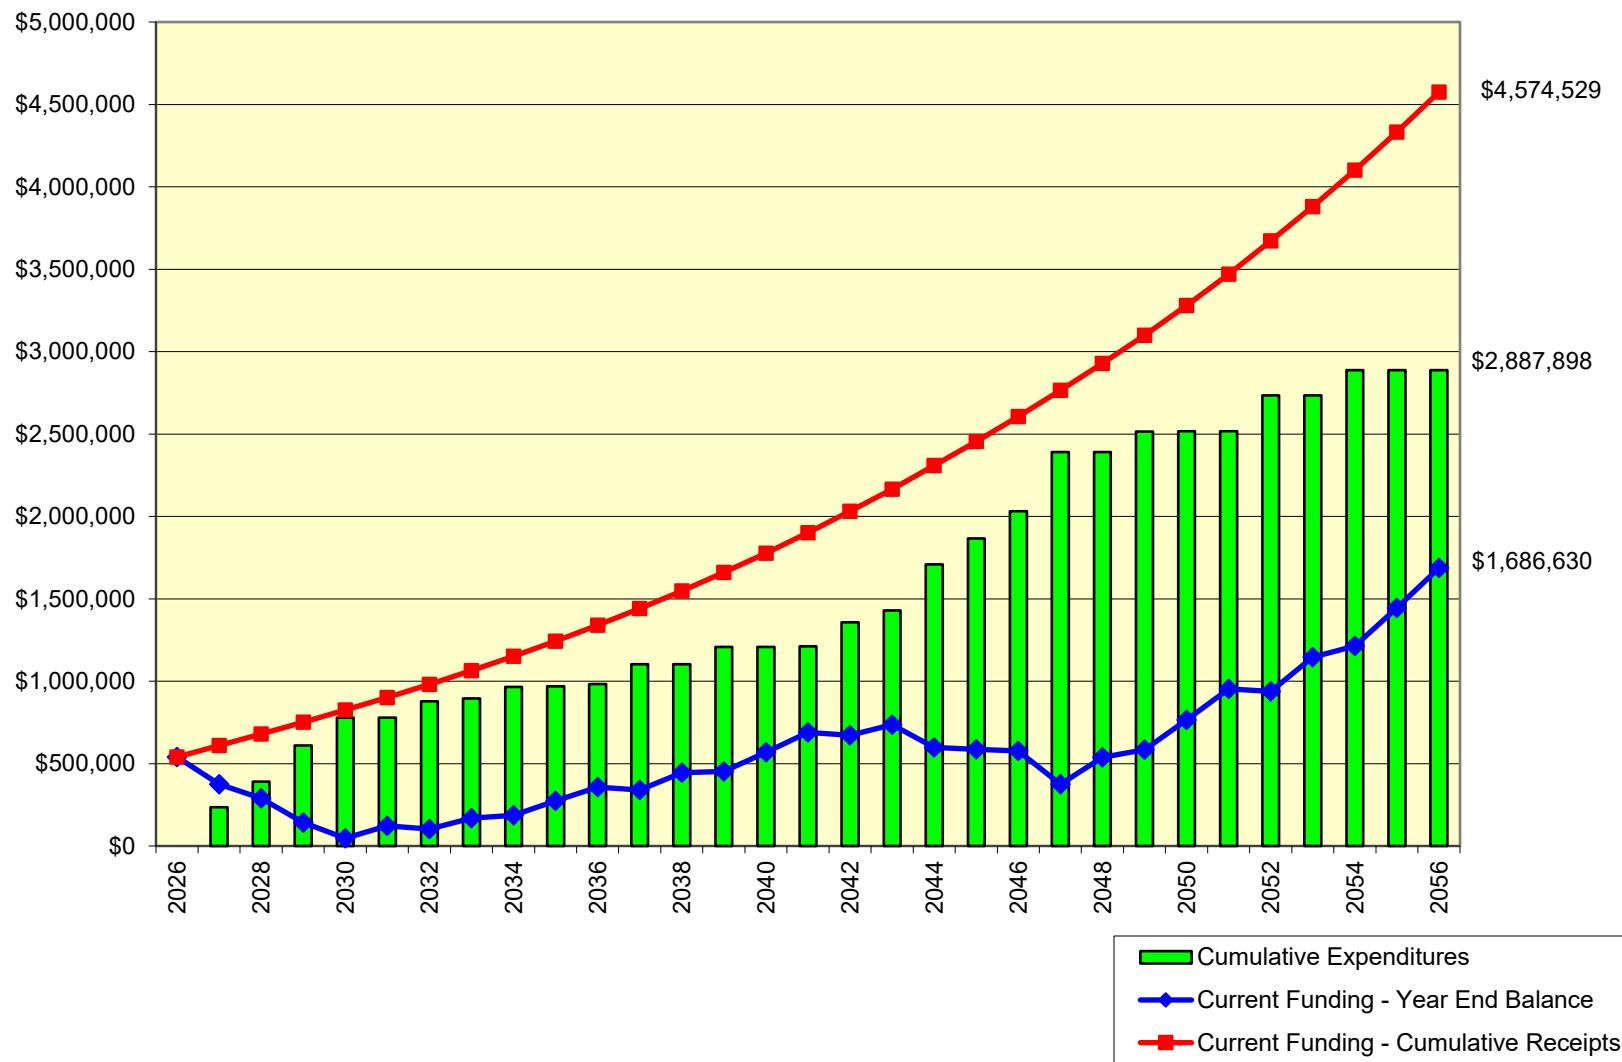
EXHIBIT C: GRAPHS
CURRENT ASSOCIATION FUNDING

Exhibit C: "*Graphs*" contains three graphs based on the numerical data found in the Reserve Funding Plan. The graphs illustrate our recommendations and observations pertaining to reserve balances, recommended annual Reserve Contributions and Reserve Expenditures during the next 30 years.
