RESERVE STUDY

The Groves at the Villages of Wetherington
Wooster, Ohio

Study Completed By:
J. R. Johnson Engineering, Inc.
6673 Eastland Road
Middleburg Hts., Ohio 44130
(440) 234-9972

September 3, 2020

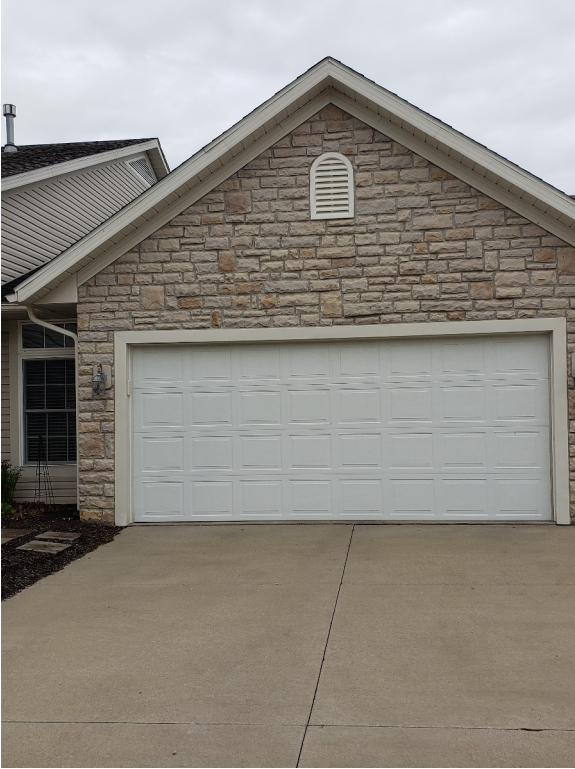
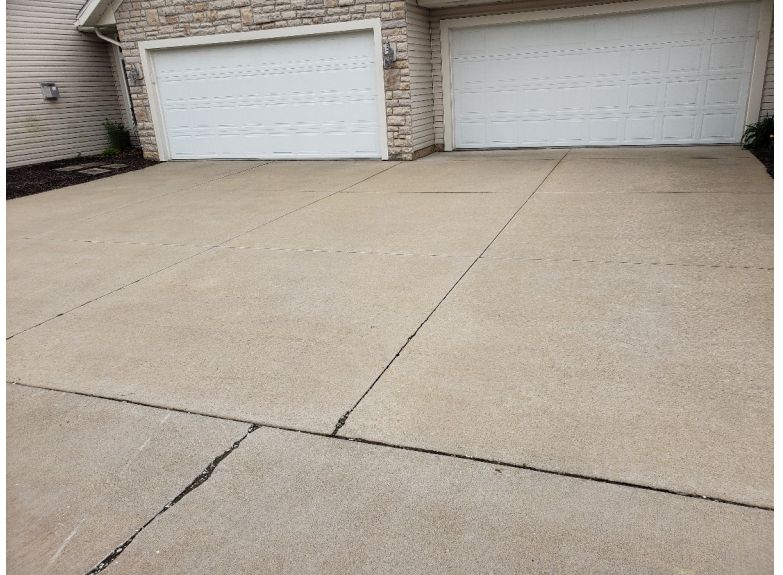
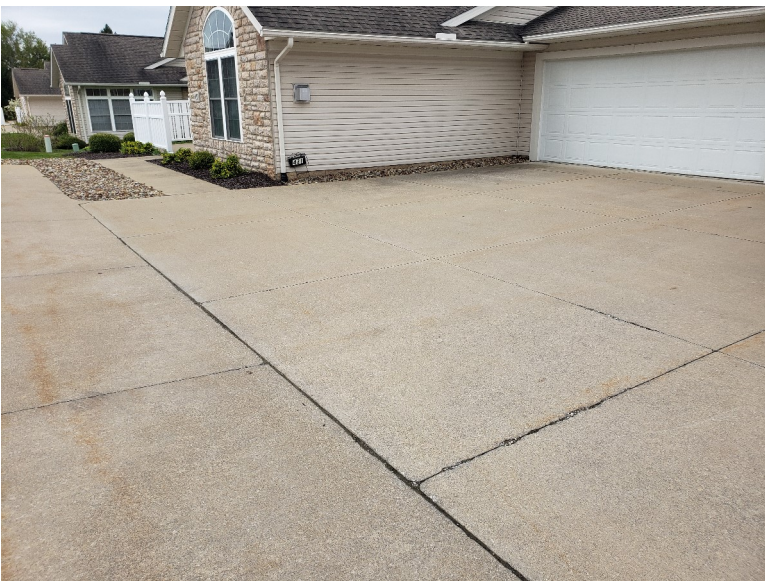
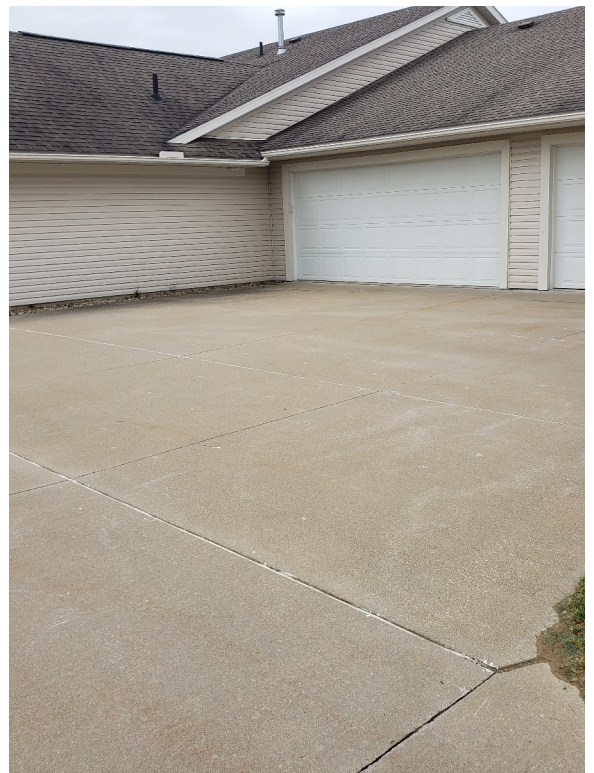
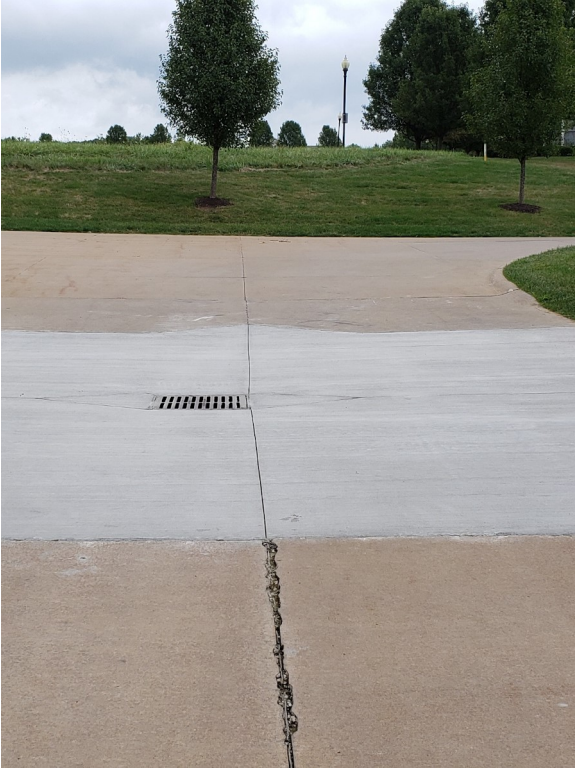
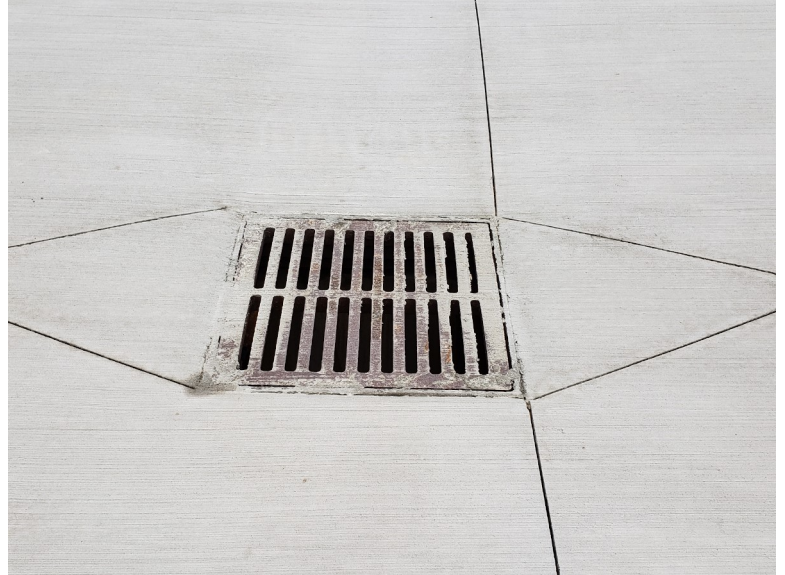
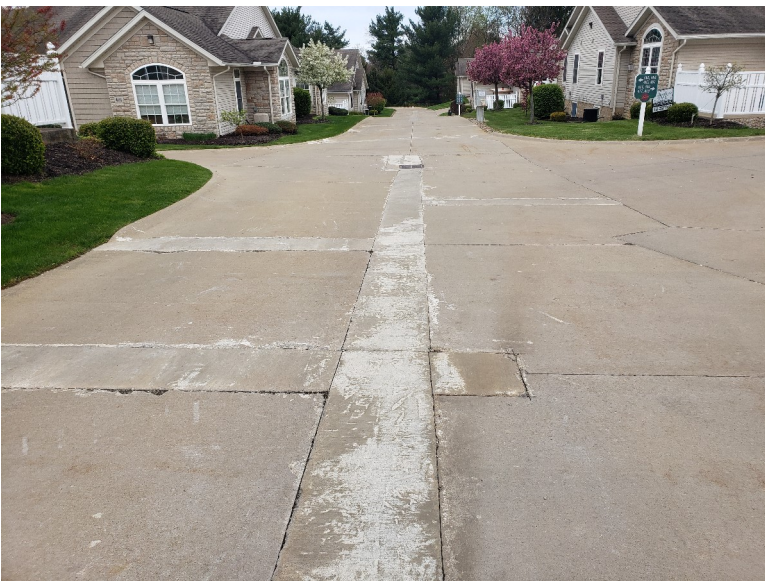
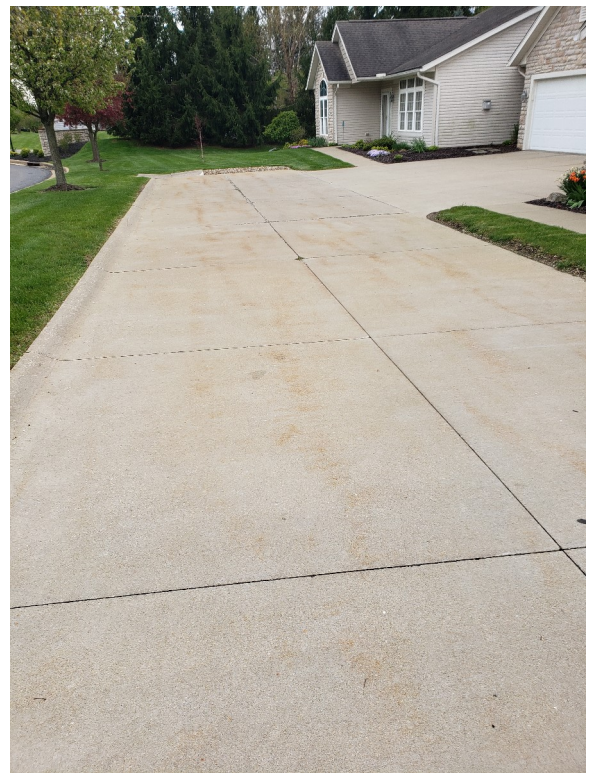
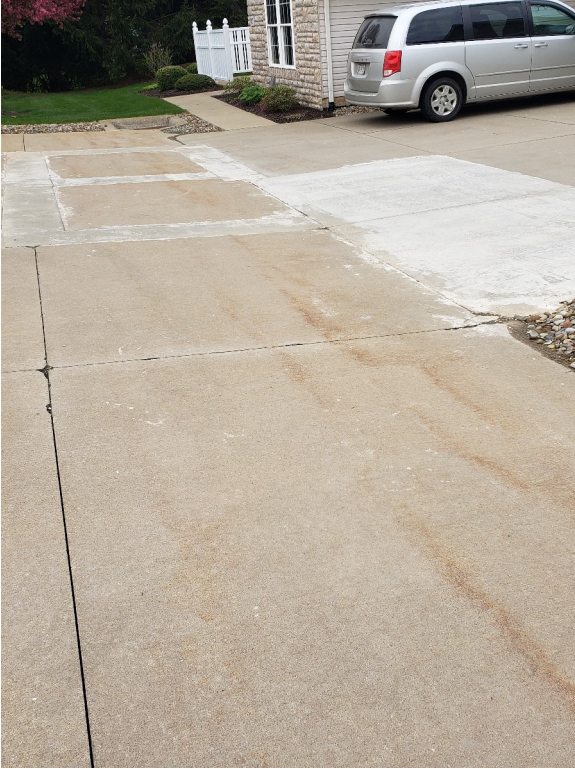
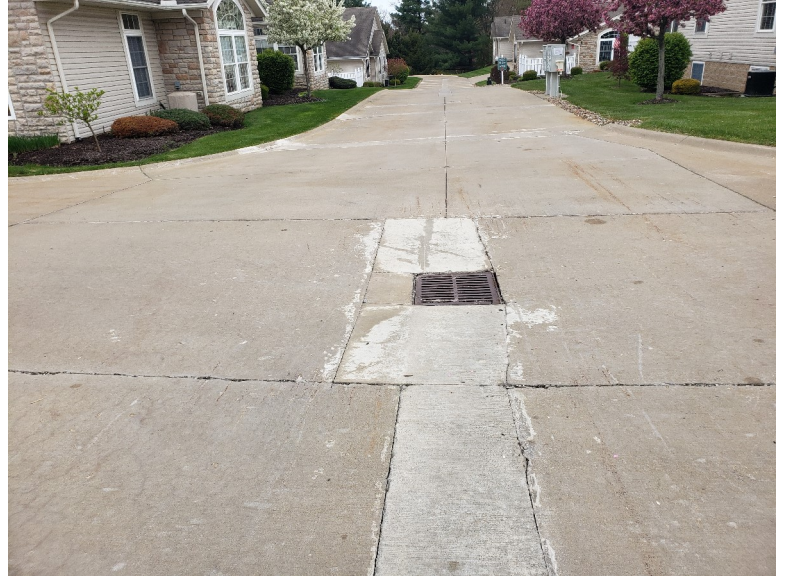
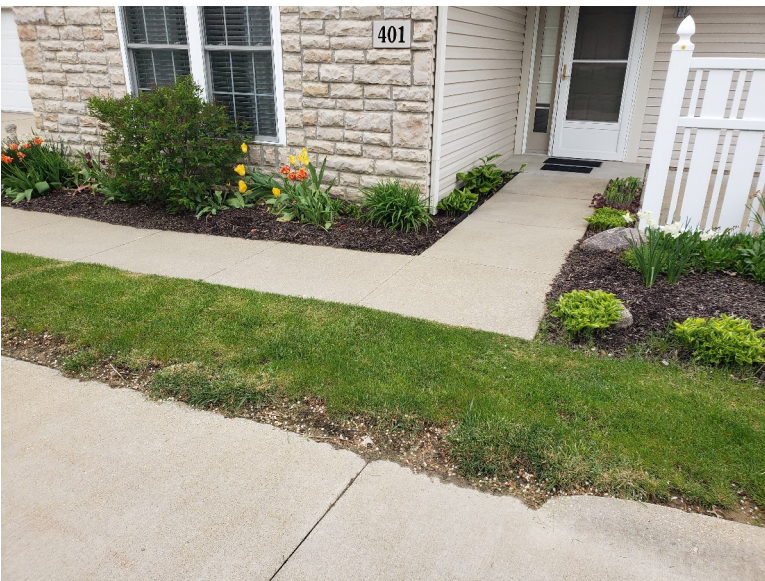
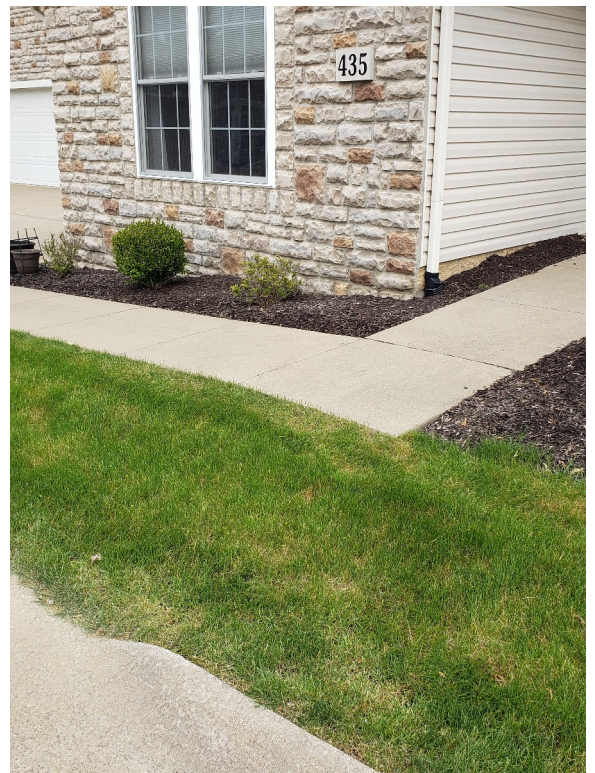
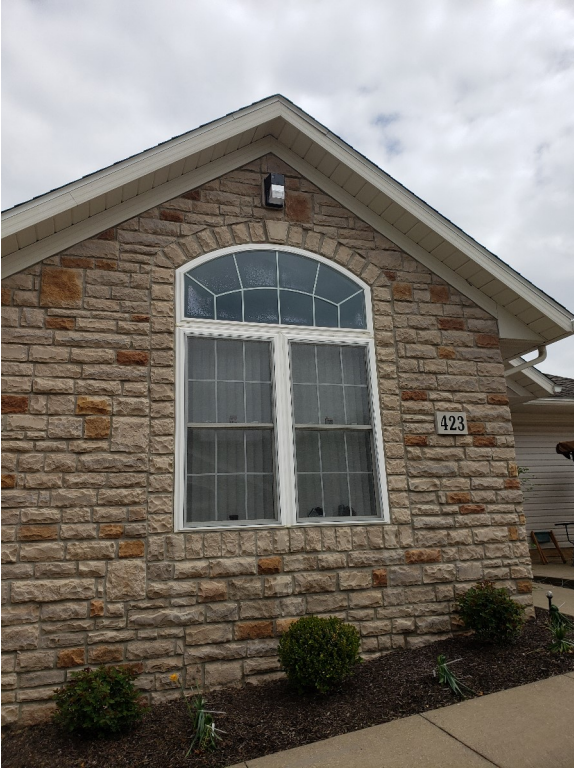
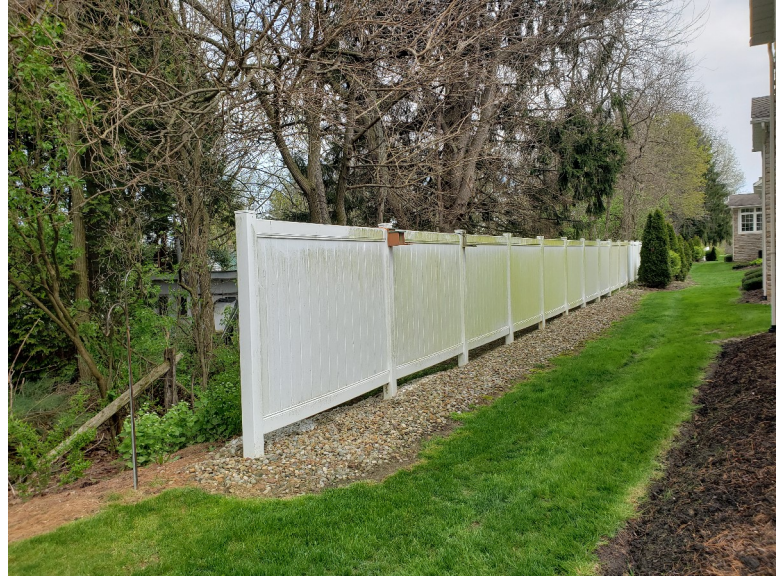
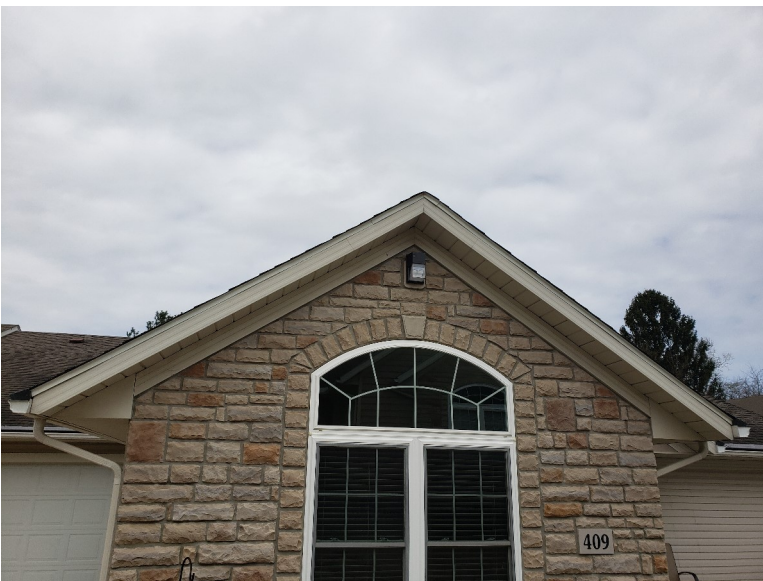
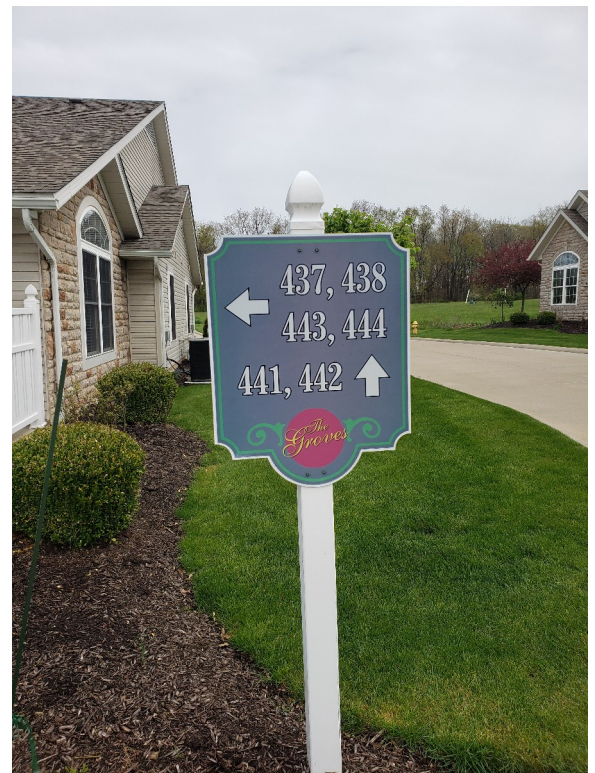
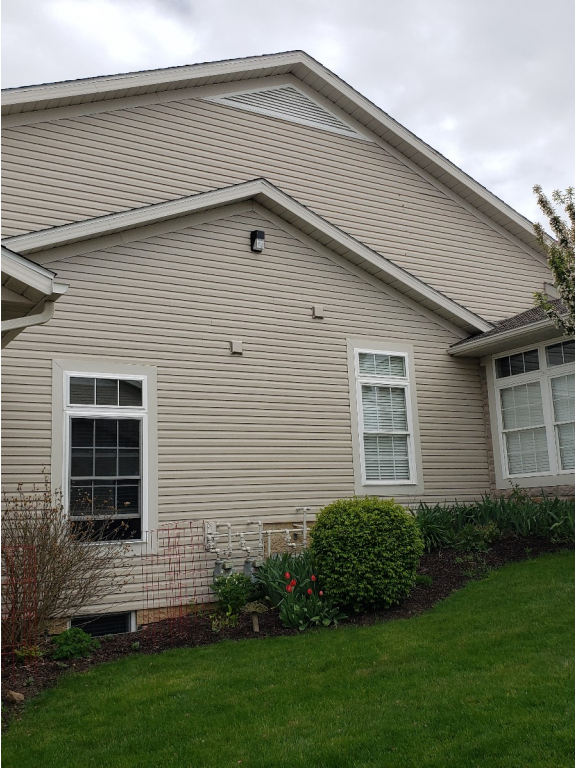
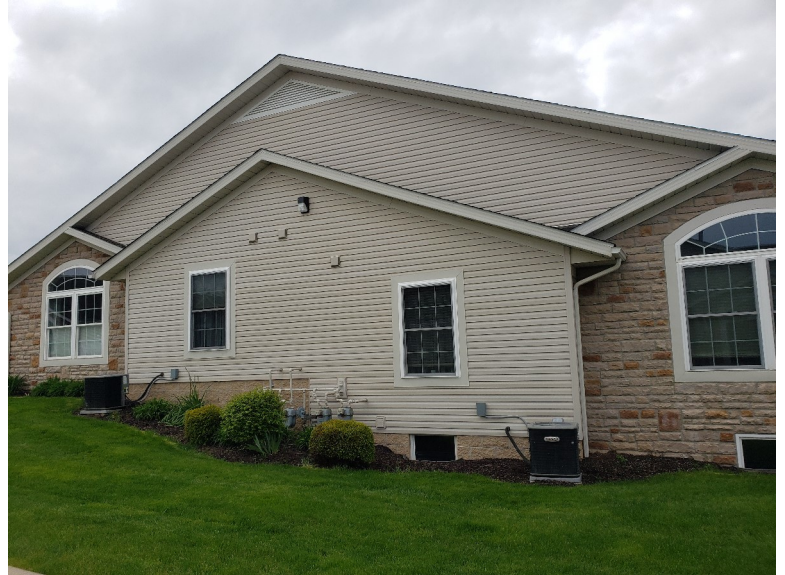
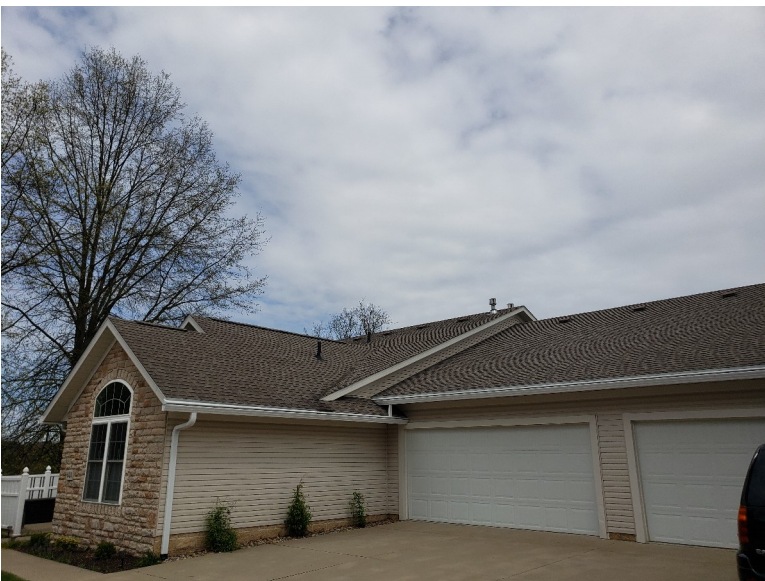
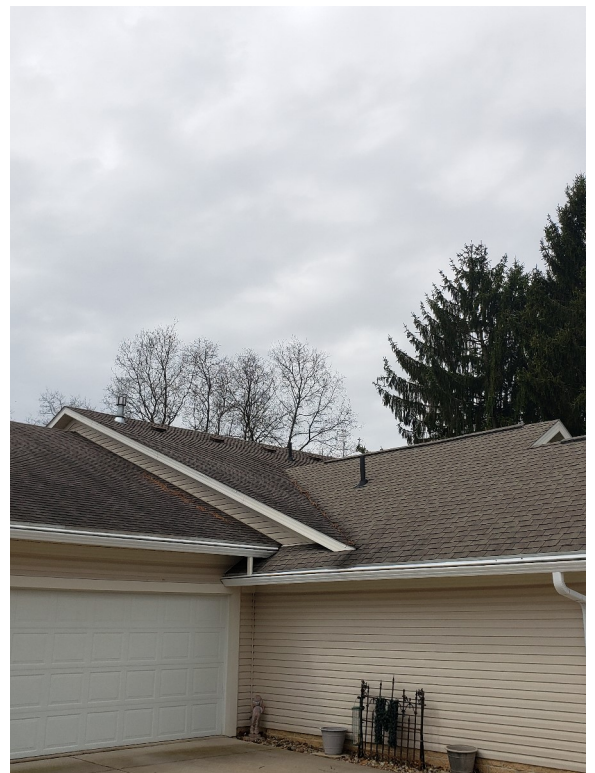
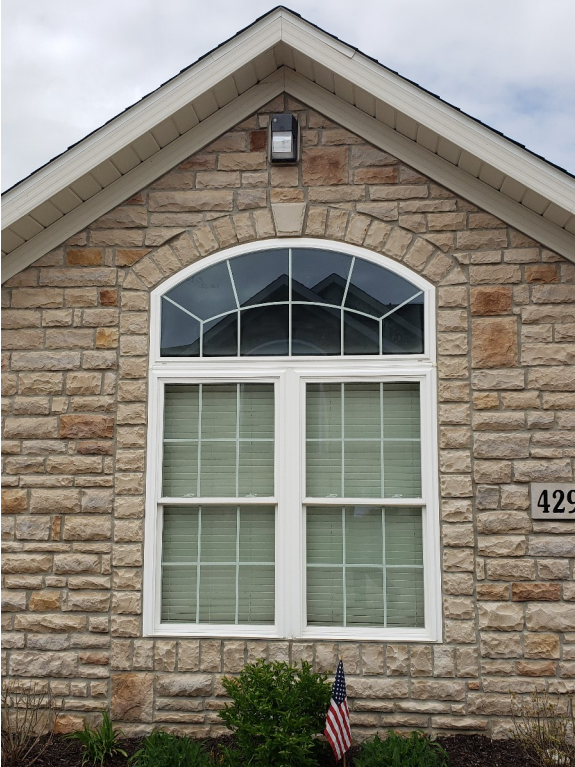
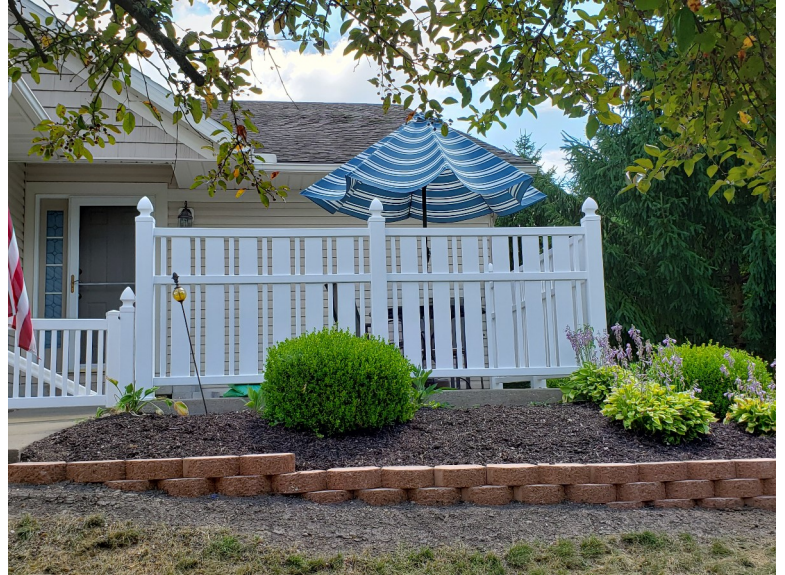
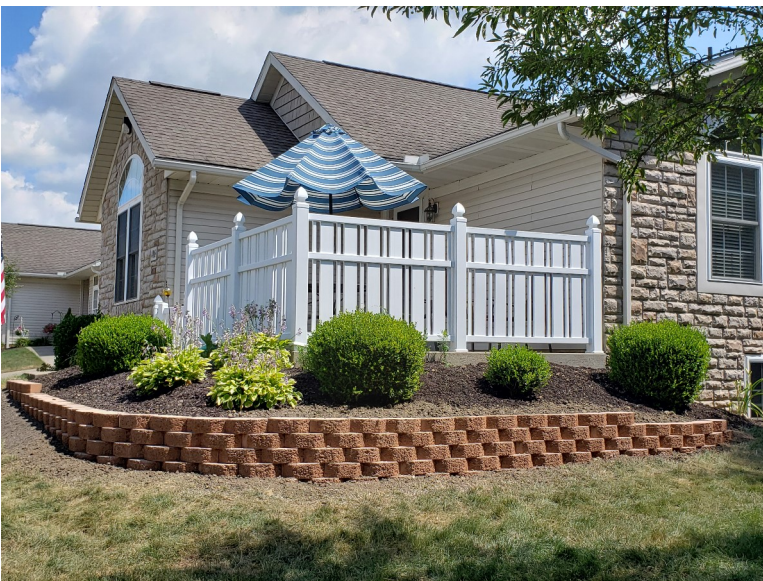
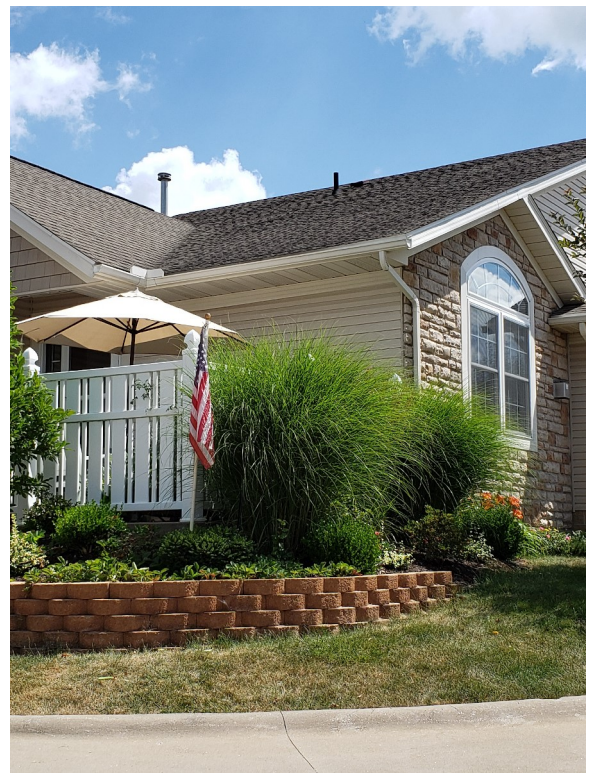
Exhibit A: Photographs

Exhibit A: *"Photographs"* documents the conditions of various property components as of the date of our visual inspection, May 6, 2020. References to these photographs are made throughout the Reserve Study.

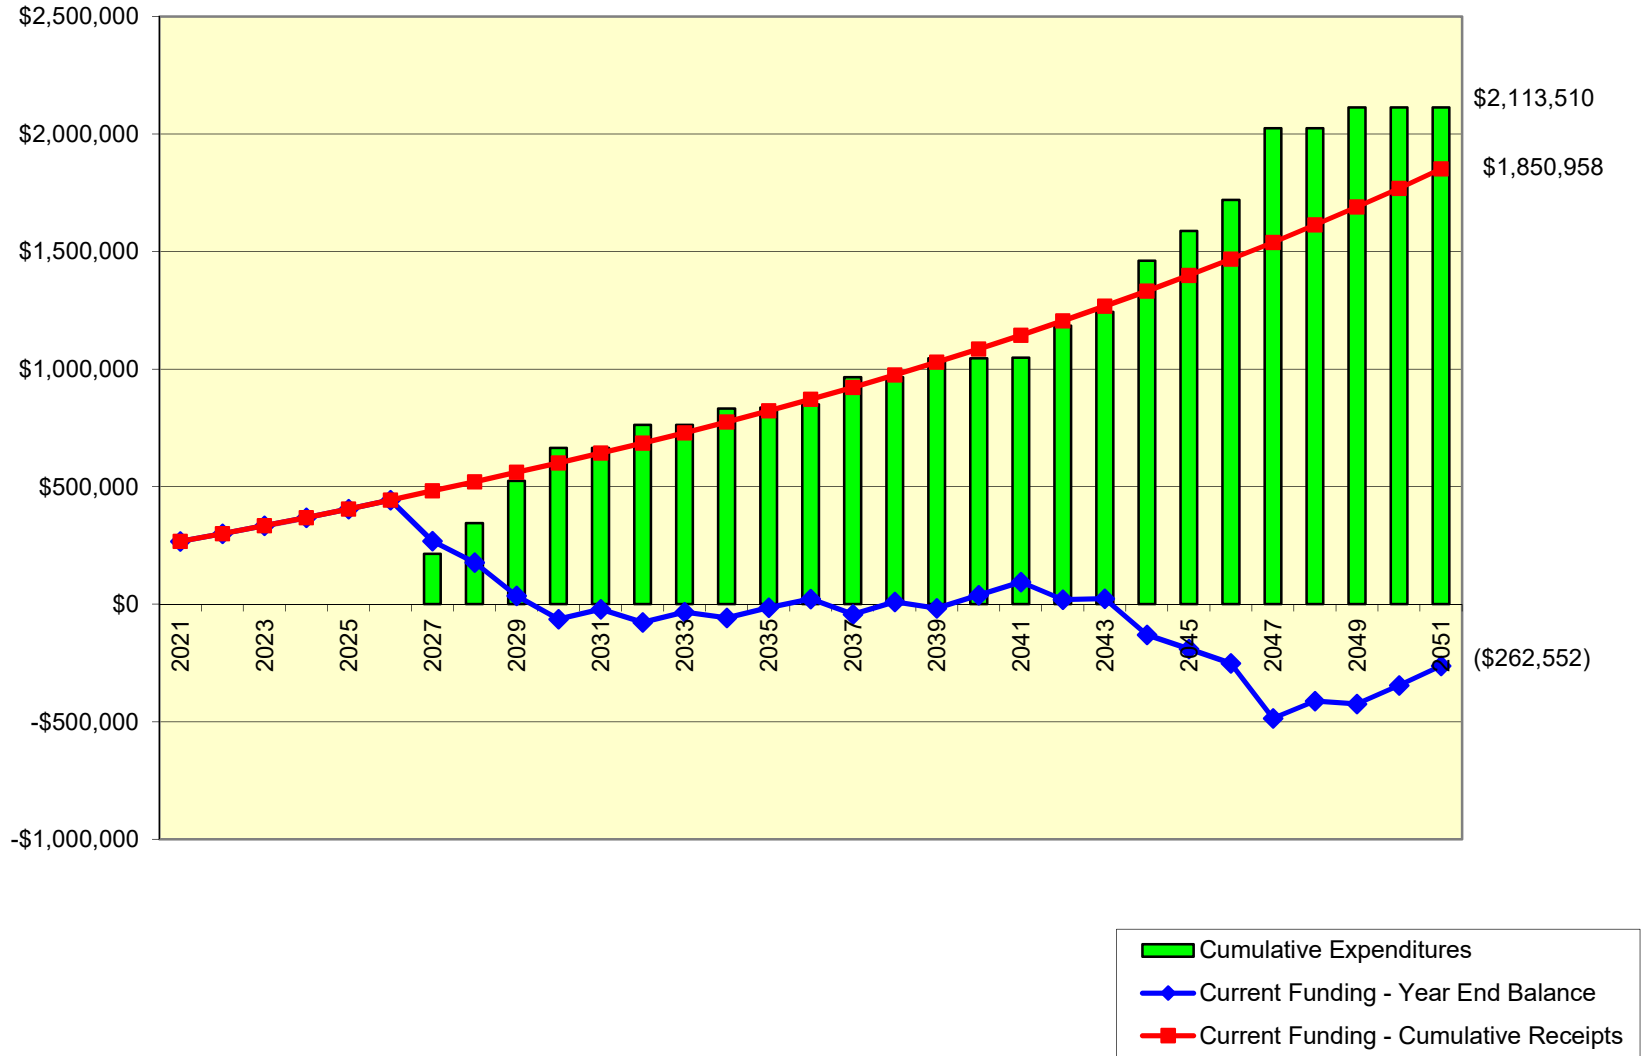
**EXHIBIT C: GRAPHS
CURRENT ASSOCIATION FUNDING**

Exhibit C: "*Graphs*" contains three graphs based on the numerical data found in the Reserve Funding Plan. The graphs illustrate our recommendations and observations pertaining to reserve balances, recommended annual Reserve Contributions and Reserve Expenditures during the next 30 years.
